FIELD OVERSIGHT SUMMARY REPORT
ACS NPL SITE
GRIFFITH, INDIANA
February 6, 1997 - March 28, 1997

**USEPA/ARCS V
BVSPC Field Oversight Summary**

Reporting Period: February 6, 1997 - March 28, 1997

Site Name/Location: ACS, Griffith, IN

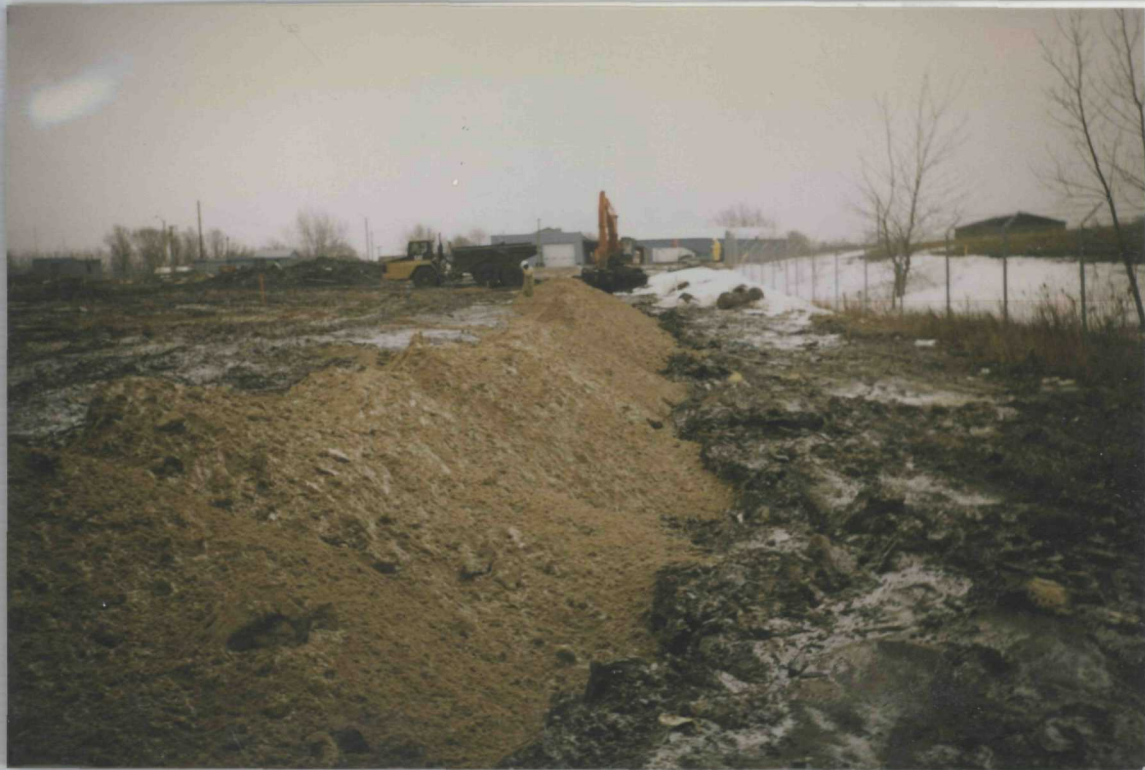
Site: American Chemical Services, Inc. RD/ERA
Proj. #: 71670.600
Roll: 1 Photo #: 1
Date: 02-06-97 Time: 1010
Photographer: Ashok Rupani
Description: Facing south. HTI conducting pre-excavation/benching activities along the western leg of the barrier wall alignment in the Off-site Containment Area (OFCA).

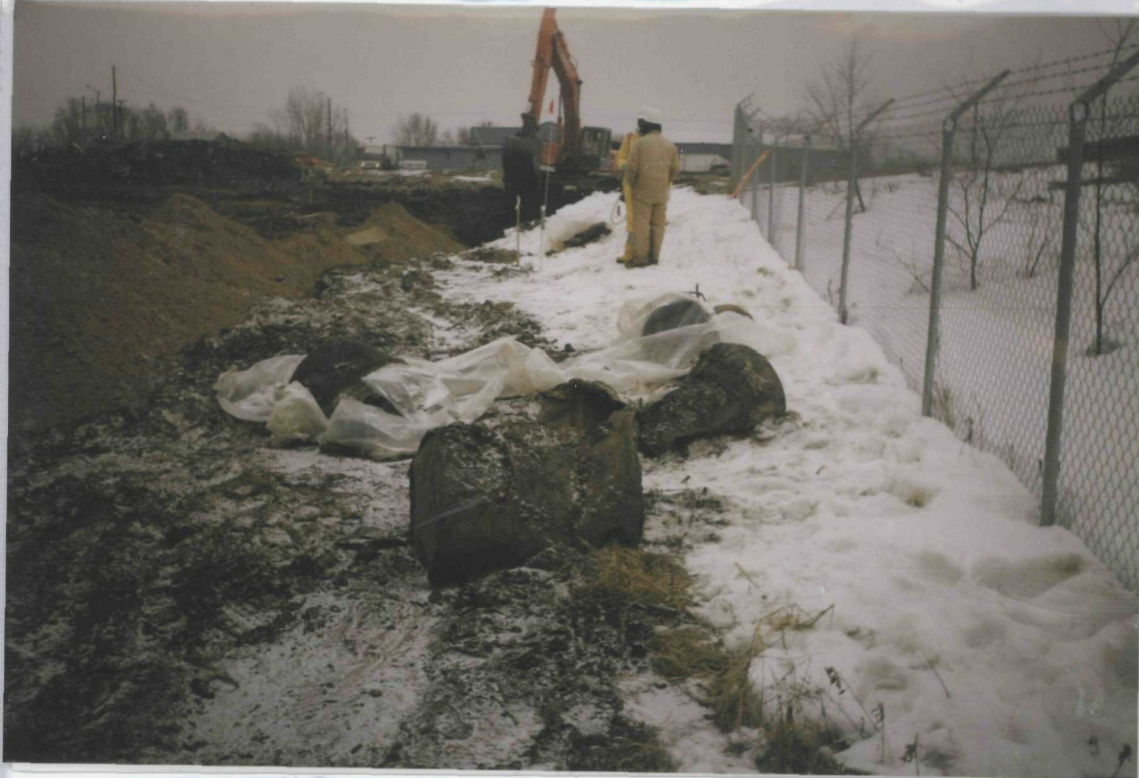
Site: American Chemical Services, Inc. RD/ERA
Proj. #: 71670.600
Roll: 1 Photo#: 2
Date: 02-06-97 Time: 1020
Photographer: Ashok Rupani
Description: Facing south. HTI conducting pre-excavation/benching activities along the western leg of the barrier wall alignment in the OFCA. Buried drums were encountered in this area.

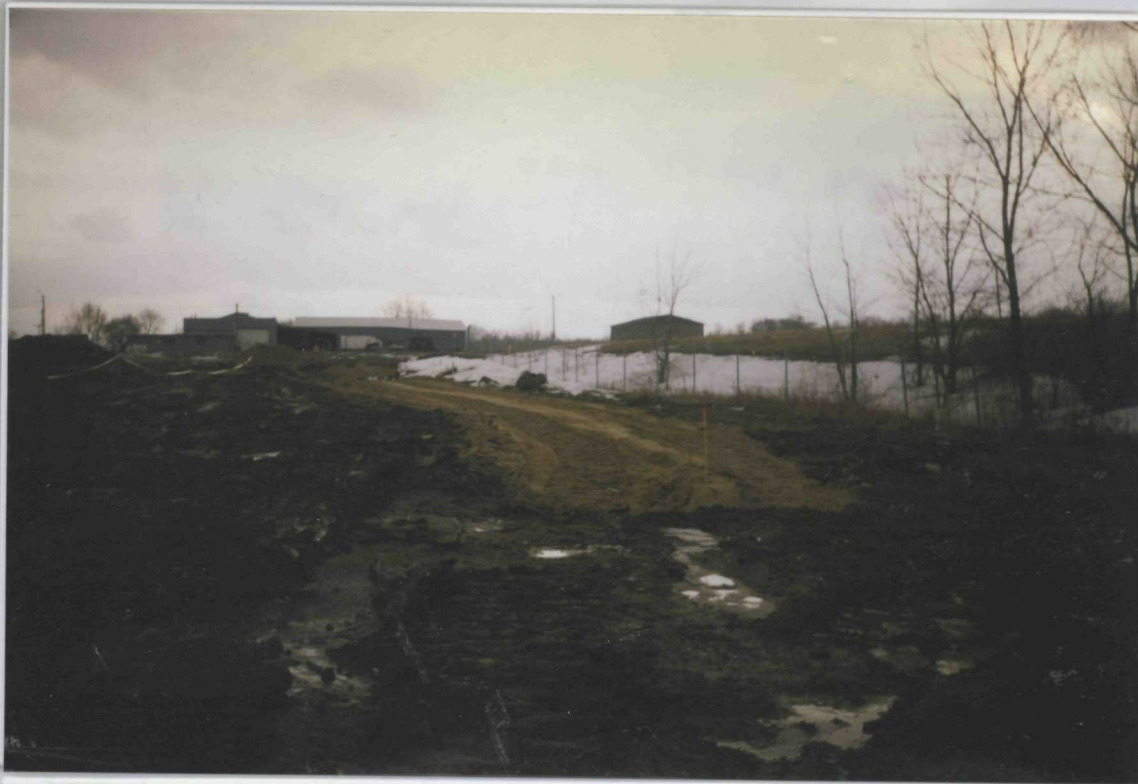
Site: American Chemical Services, Inc. RD/ERA
Proj. #: 71670.600
Roll: 1 Photo #: 4
Date: 02-09-97 Time: 1345
Photographer: Ashok Rupani
Description: Facing south-west. HTI completes pre-
excavation/benching activities along a section of the
western leg of the barrier wall alignment in the OFCA.

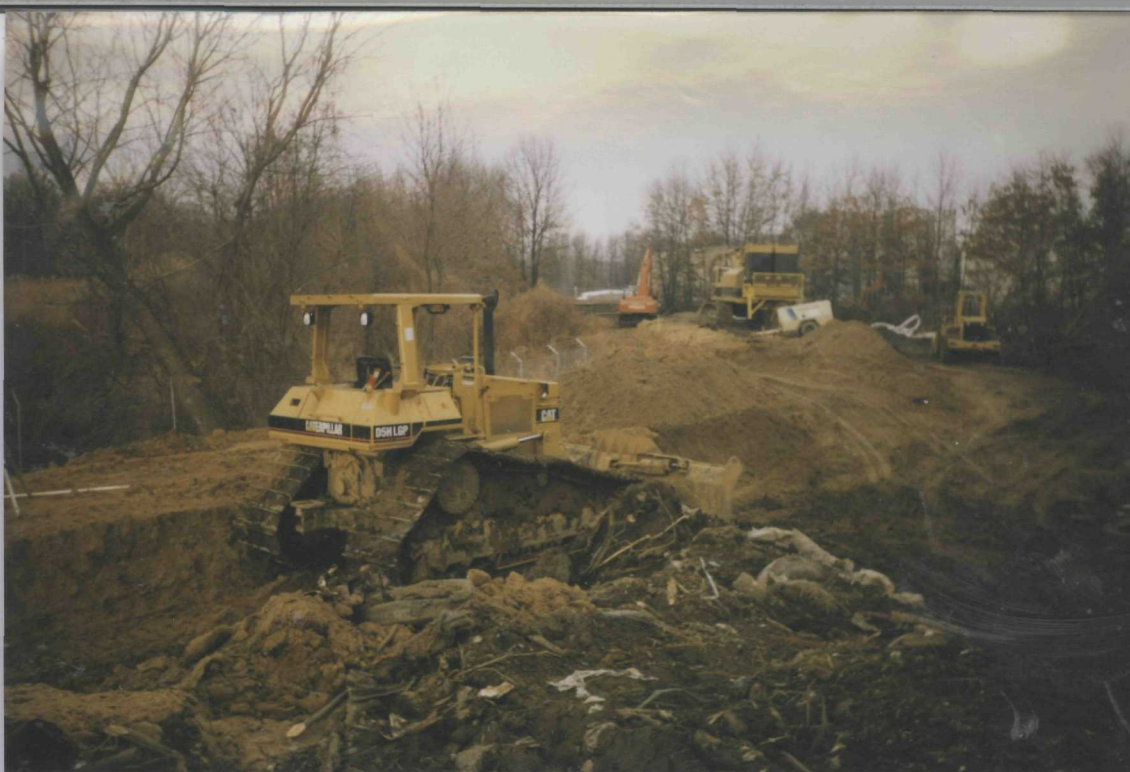
Site: American Chemical Services, Inc. RD/ERA
Proj. #: 71670.600
Roll: 1 Photo #: 5
Date: 02-09-97 Time: 1345
Photographer: Ashok Rupani
Description: Facing north-west. HTI conducting pre-excavation/benching activities along the western leg of the barrier wall alignment in the OFCA.

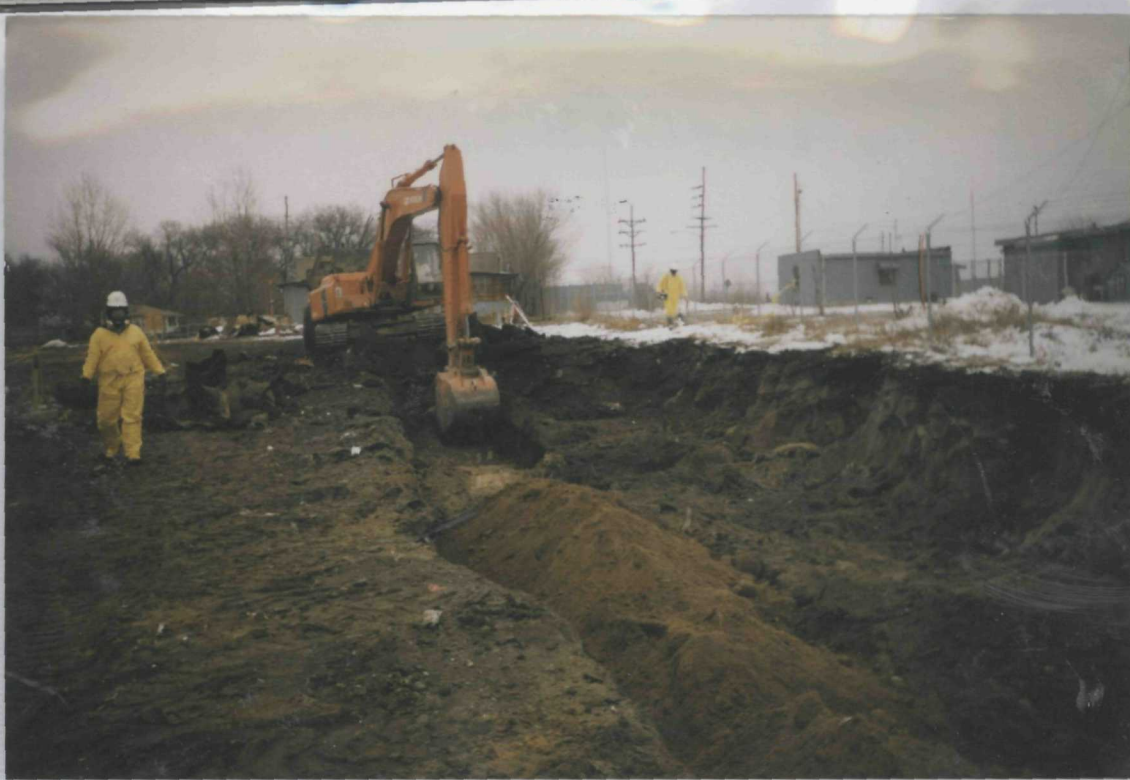
Site: American Chemical Services, Inc. RD/ERA
Proj. #: 71670.600
Roll: 1 Photo #: 7
Date: 02-14-97 Time: 1420
Photographer: Ashok Rupani
Description: Facing south. HTI conducting pre-excavation/benching activities along the western leg of the barrier wall alignment in the OFCA.

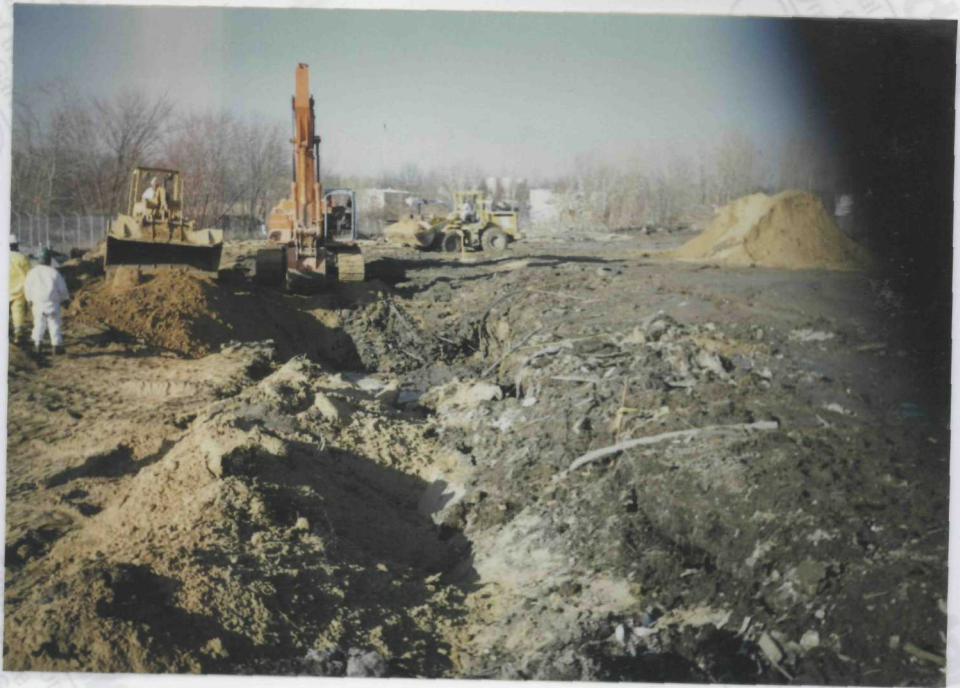
Description: Facing north. HTI conducting pre-excavation/benching activities along the alignment of extraction trench #13. During these activities, HTI accidentally damaged barrier wall conveyance piping installed by Youngs.

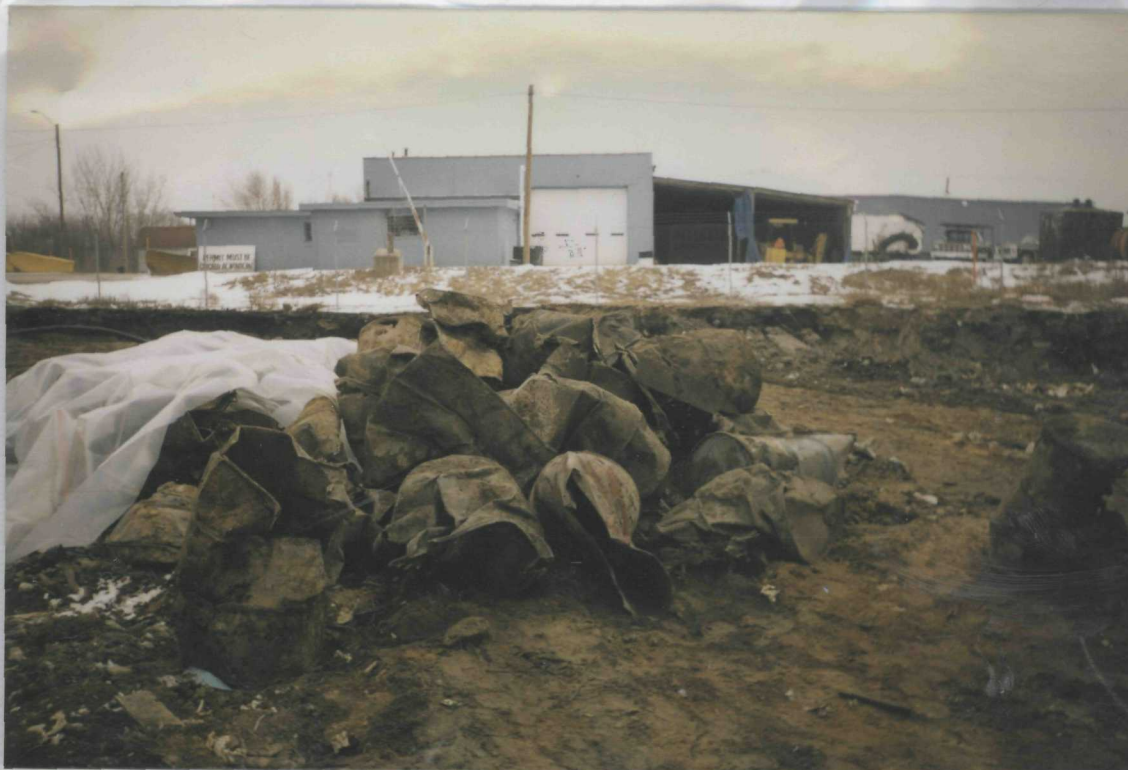
Site: American Chemical Services, Inc. RD/ERA
Proj. #: 71670.600
Roll: 1 Photo #: 9
Date: 02-14-97 Time: 1330
Photographer: Ashok Rupani
Description: Facing south-west. During pre-excavation/benching activities along the southern leg of the barrier wall alignment, HTI uncovered several buried drums.

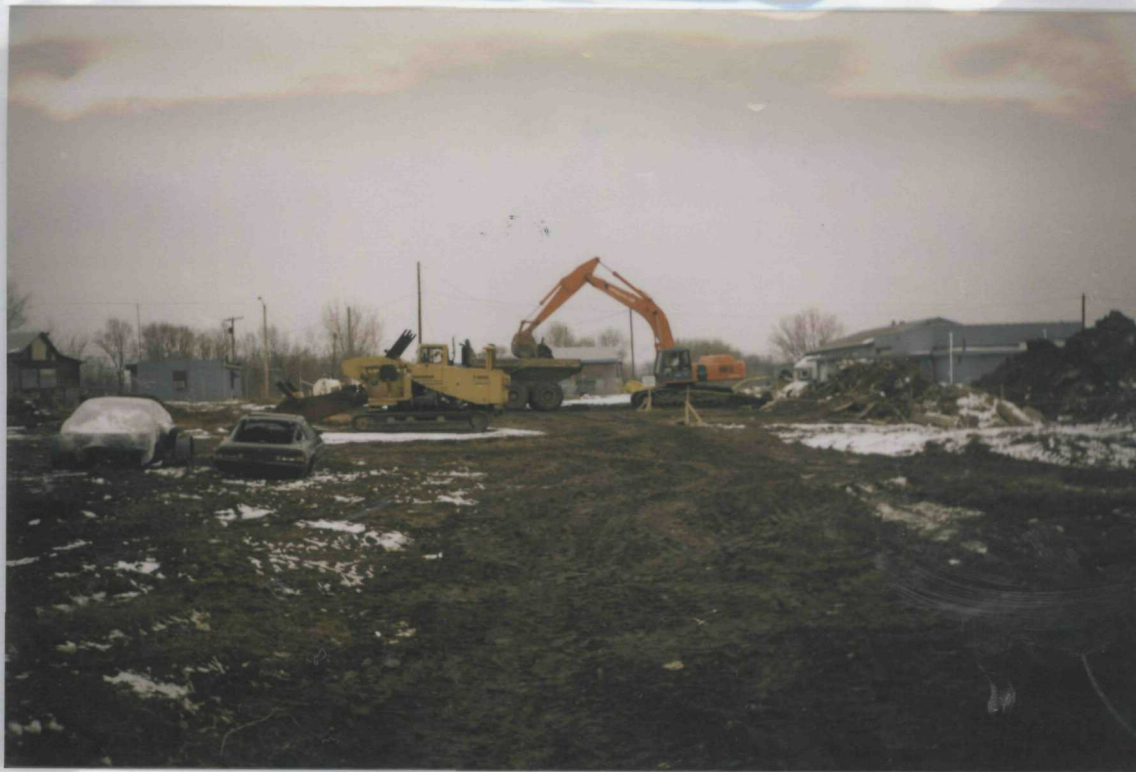
Site: American Chemical Services, Inc. RD/ERA
Proj. #: 71670.600
Roll: 3 Photo #: 10
Date: 02-27-97 Time: 1005
Photographer: Ashok Rupani
Description: Facing north-west. Drums shown in Photo #9 were temporarily covered with plastic.

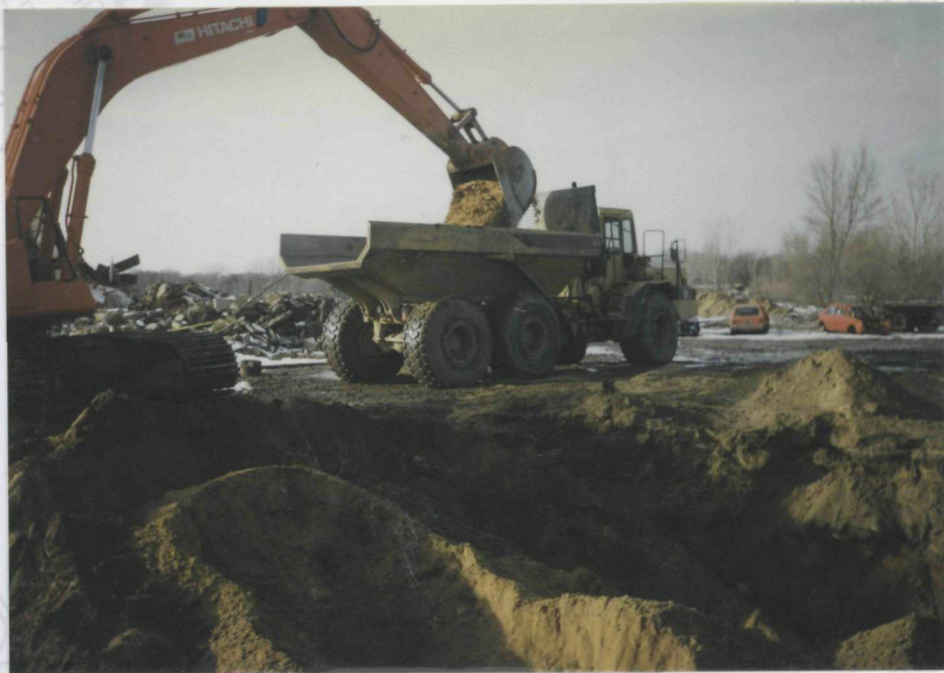
Description: Facing west. HTI conducting pre-excavation/benching activities along the southern leg of the barrier wall alignment. Excavated municipal waste/debris and soils were handled in accordance with the approved Spoils Management Plan.

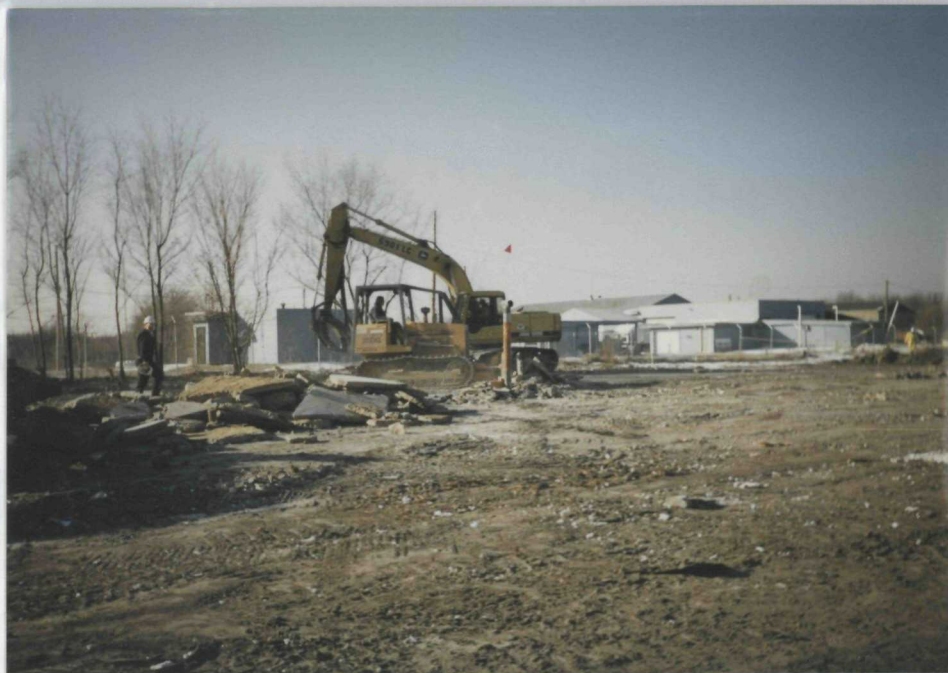
Description: Facing north-west. HTI conducting pre-excavation/benching activities along the southern leg of the barrier wall alignment. Excavated municipal waste/debris and soils were handled in accordance with the approved Spoils Management Plan.

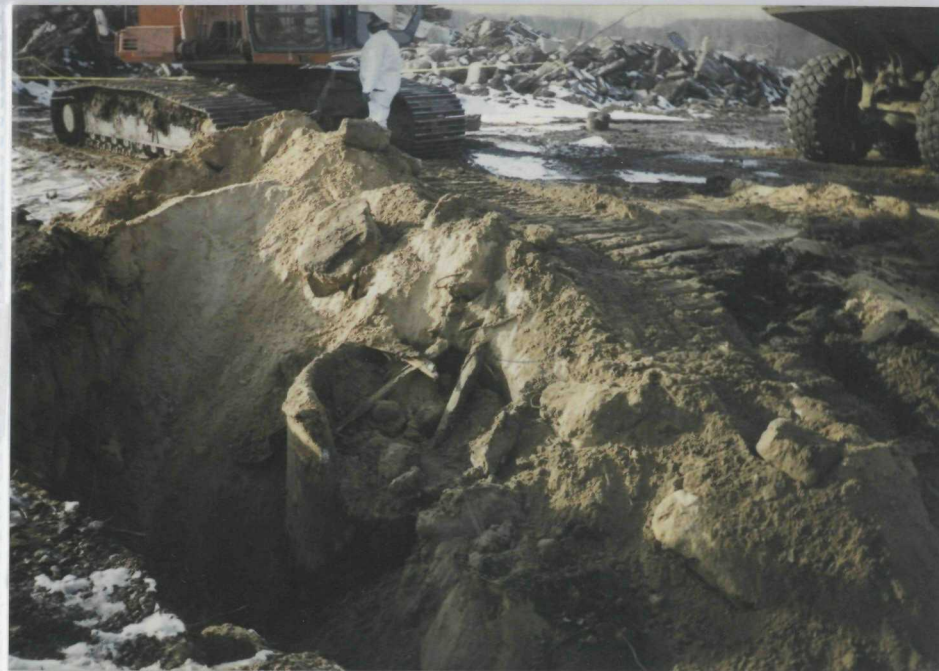
Photo #: 21
 Time: 1520
 Description: Facing west. An abandoned concrete septic tank was encountered during pre-excavation/benching activities underneath the former Kapica-Pazmey building located at south-east corner of the OFCA.

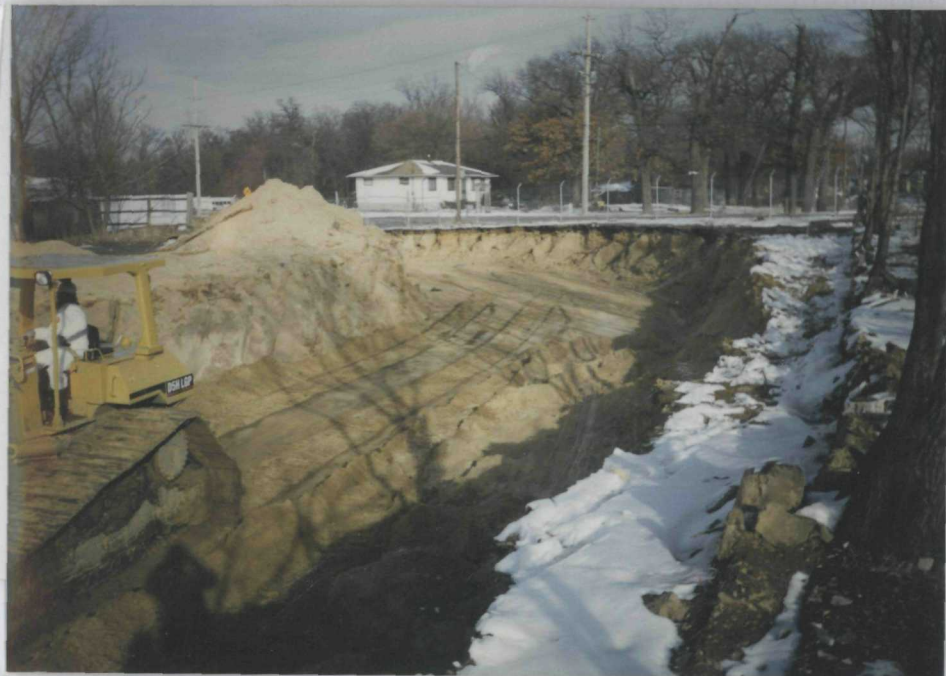
Photo #: 22
 Time: 1520
 Description: Facing west. An abandoned concrete septic tank was encountered during pre-excavation/benching activities underneath the former Kapica-Pazmey building located at south-east corner of the OFCA.

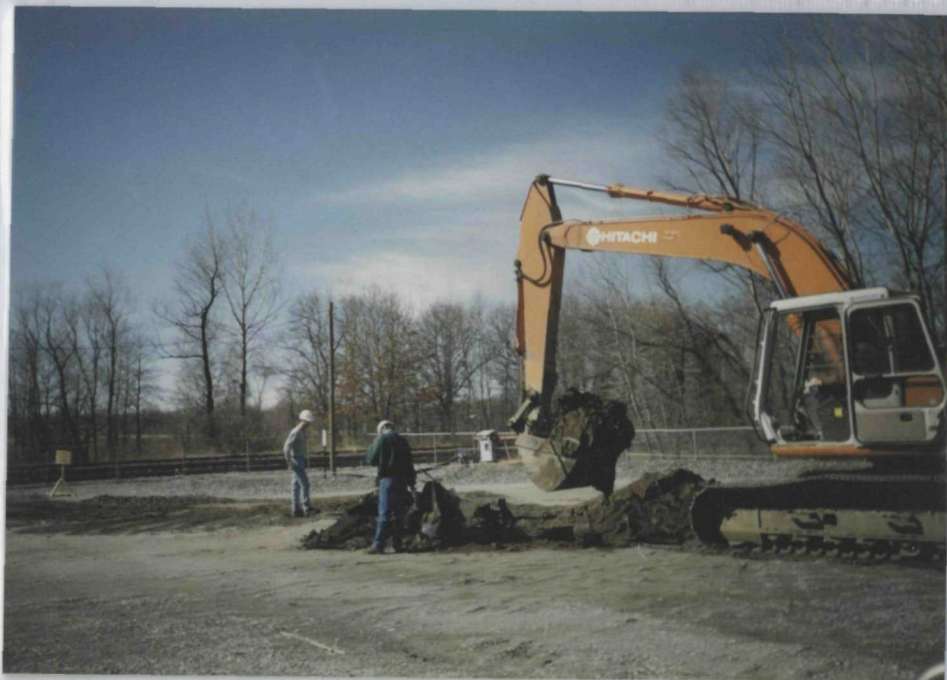
Site: American Chemical Services, Inc. RD/ERA
 Proj. #: 71670.600
 Roll: 4 Photo #: 24
 Date: 03-19-97 Time: 0940
 Photographer: Ashok Rupani
 Description: Facing south-west. Midwest Material Services of Hammond, Indiana, conducting pre-trenching activities along barrier wall alignment in the south-west region of the On-site Containment Area (ONCA).

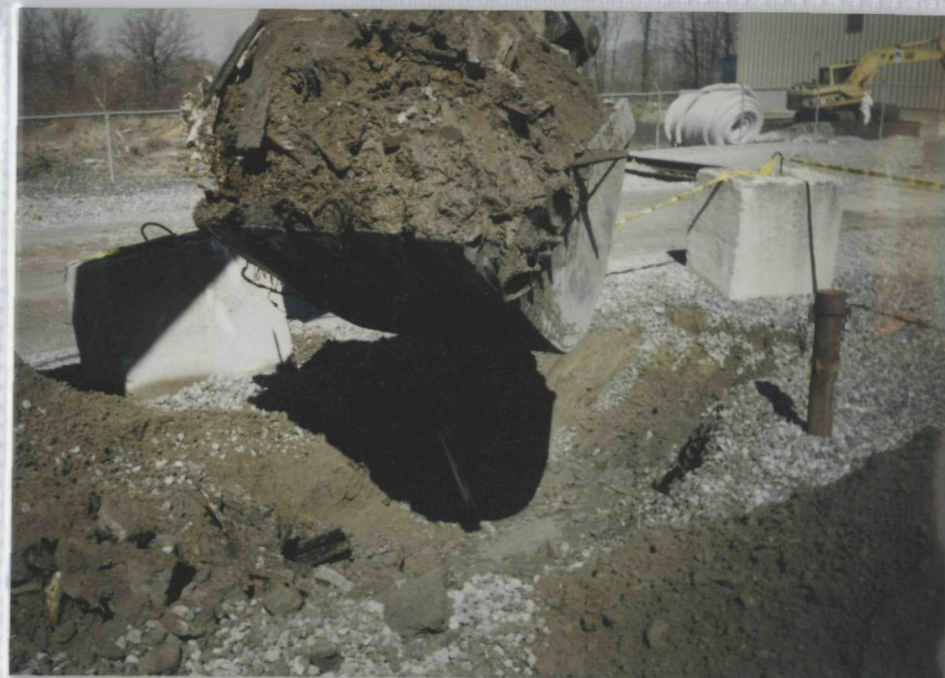
Description: Facing south-west. Some waste materials/debris were encountered during pre-trenching activities along barrier wall alignment in the south-west region of the ONCA.

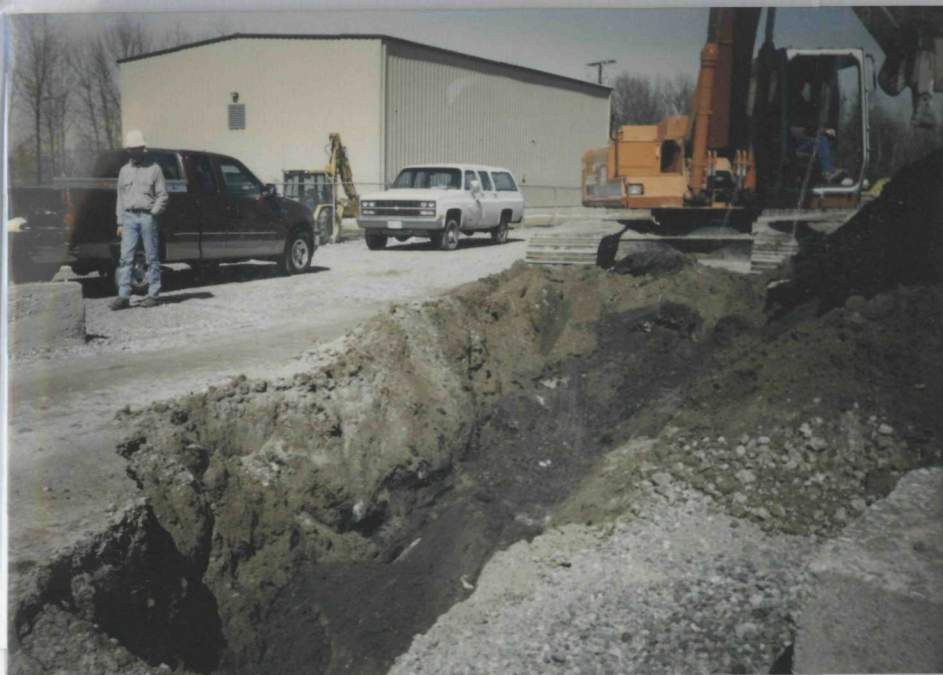
Description: Facing north-west. Some waste materials/debris were encountered during pre-trenching activities along barrier wall alignment in the south-west region of the ONCA.

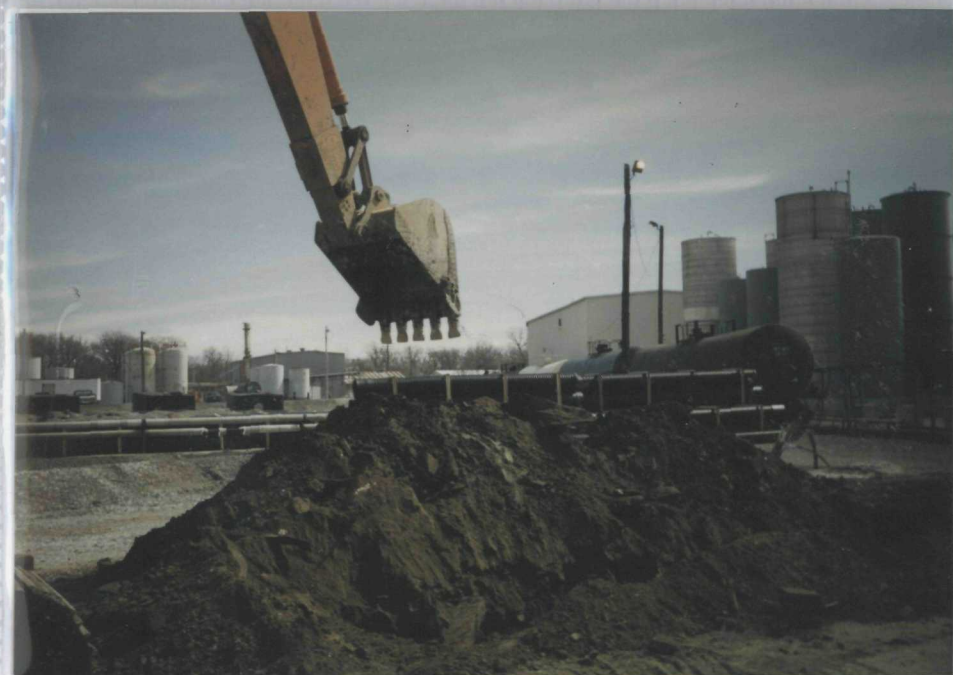
Site: American Chemical Services, Inc. RD/ERA
 Proj. #: 71670.600
 Roll: 4 Photo #: 27
 Date: 03-19-97 Time: 1220
 Photographer: Ashok Rupani
 Description: Facing north-west. Some waste materials/debris were encountered during pre-trenching activities along barrier wall alignment in the south-west region of the ONCA.

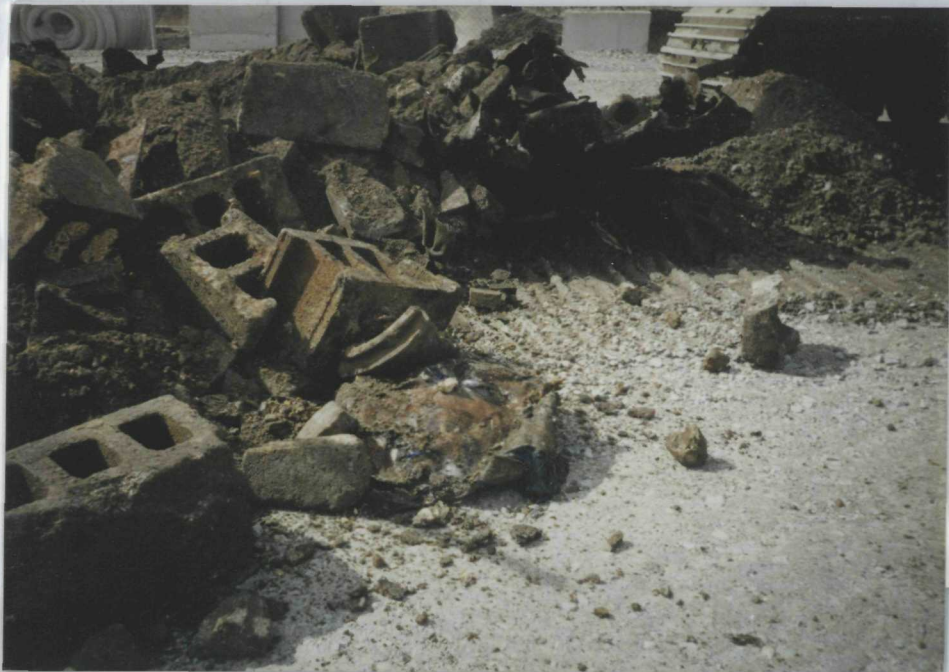
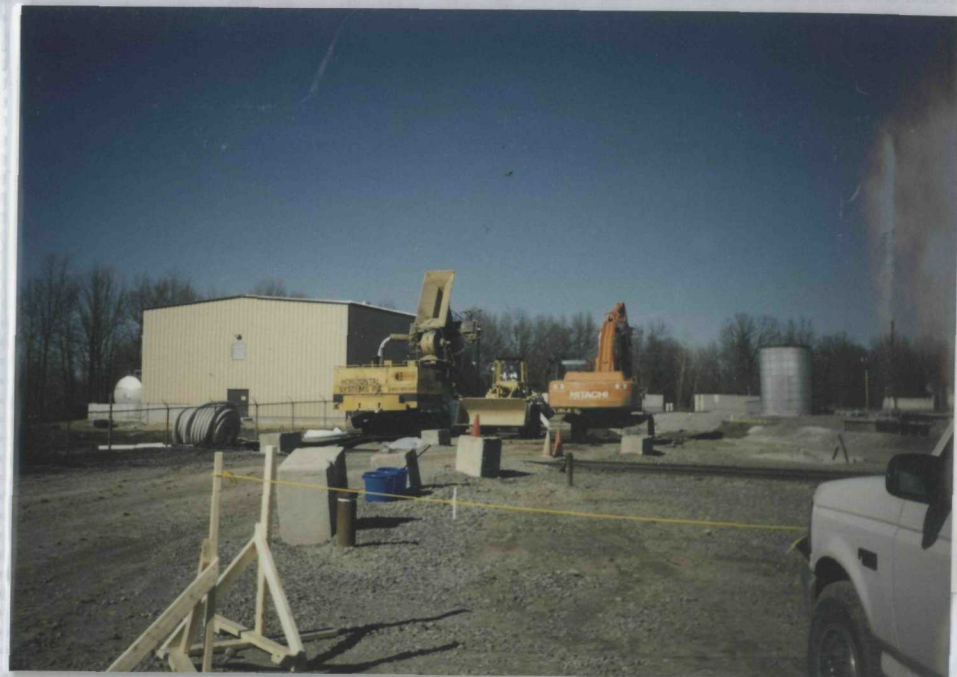
Site: American Chemical Services, Inc. RD/ERA
 Proj. #: 71670.600
 Roll: 4 Photo #: 28
 Date: 03-19-97 Time: 1240
 Photographer: Ashok Rupani
 Description: Facing south-east. Some waste materials/debris were encountered during pre-trenching activities along barrier wall alignment in the south-west region of the ONCA.

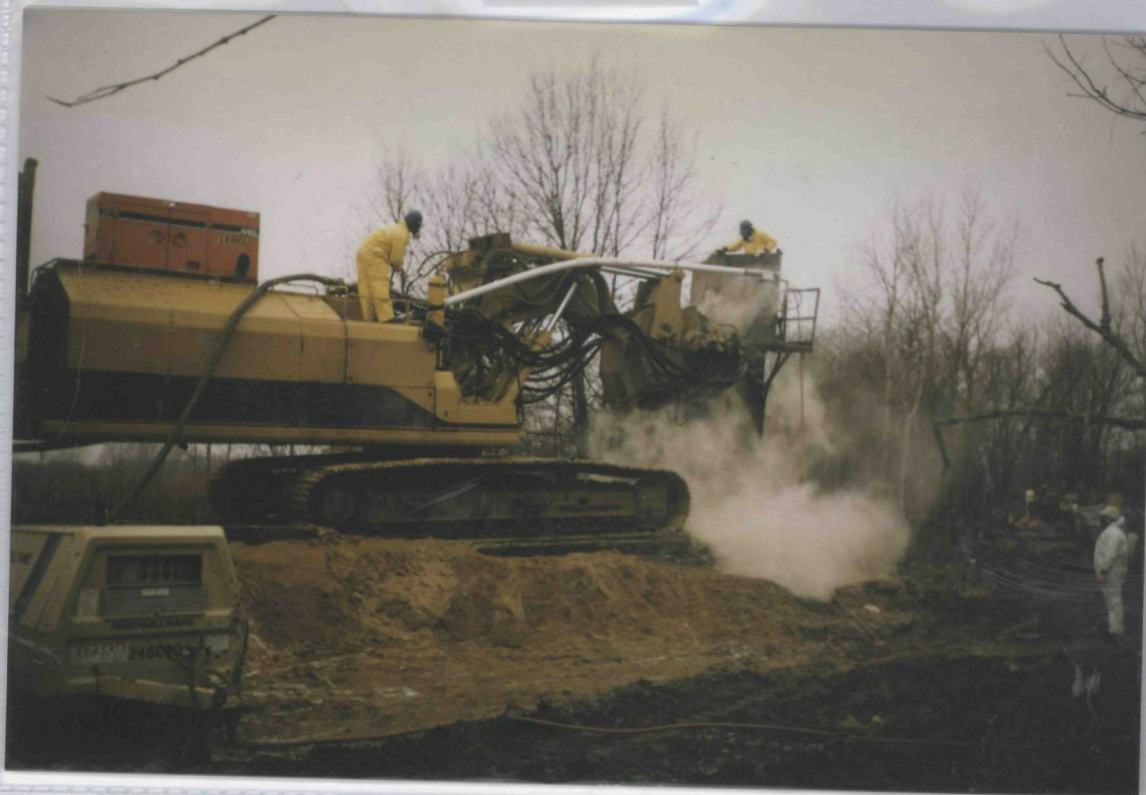
Description: Facing west. HTI conducting pre-excavation activities along the alignment of extraction trench #10. Excavated waste/debris was handled in accordance with the approved Spoils Management Plan.

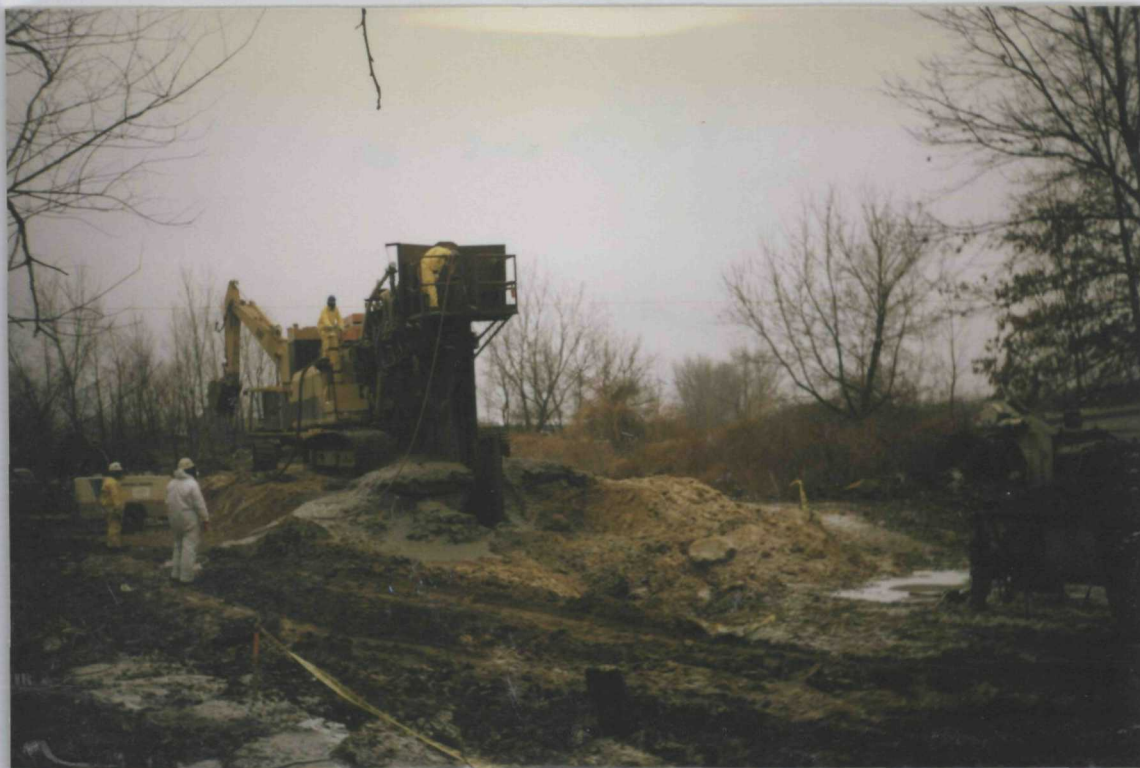
Site: American Chemical Services, Inc. RD/ERA
Proj. #: 71670.600
Roll: 1 Photo #: 33
Date: 02-06-97 Time: 0930
Photographer: Ashok Rupani
Description: Facing north-west. HTI installing barrier wall in the
north-west region of the OFCA.

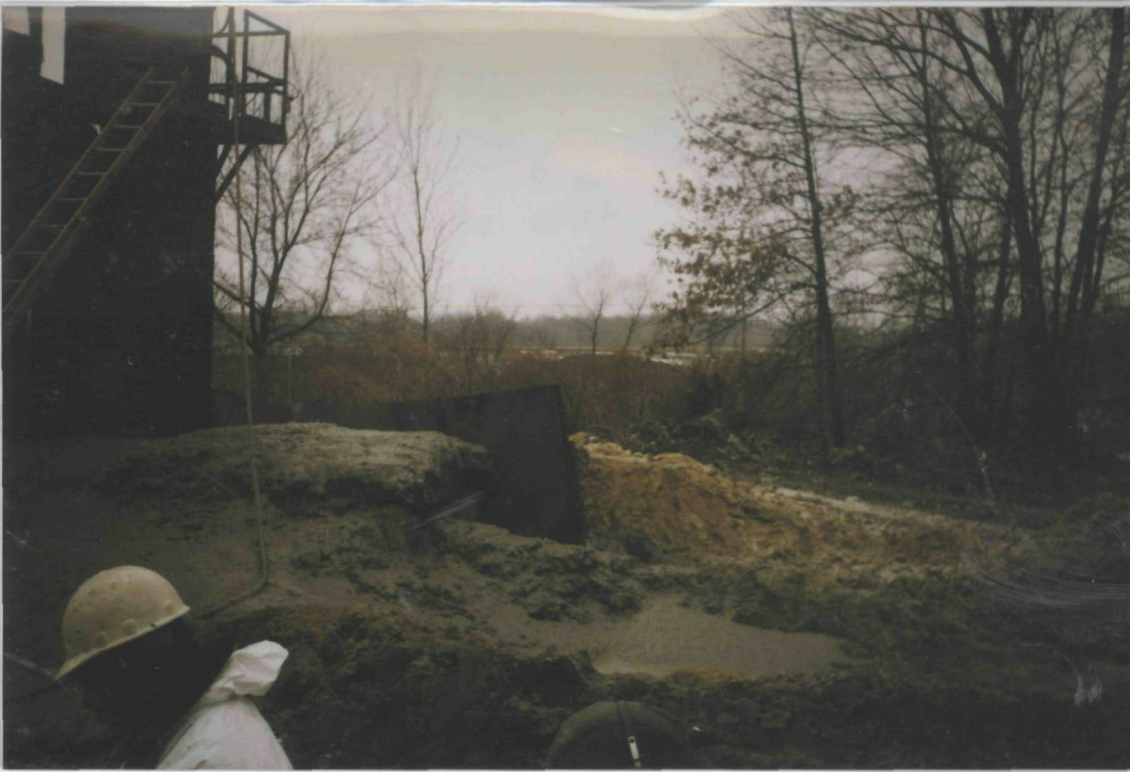
Description: Facing south-west. HTI installing barrier wall in the north-west region of the OFCA.

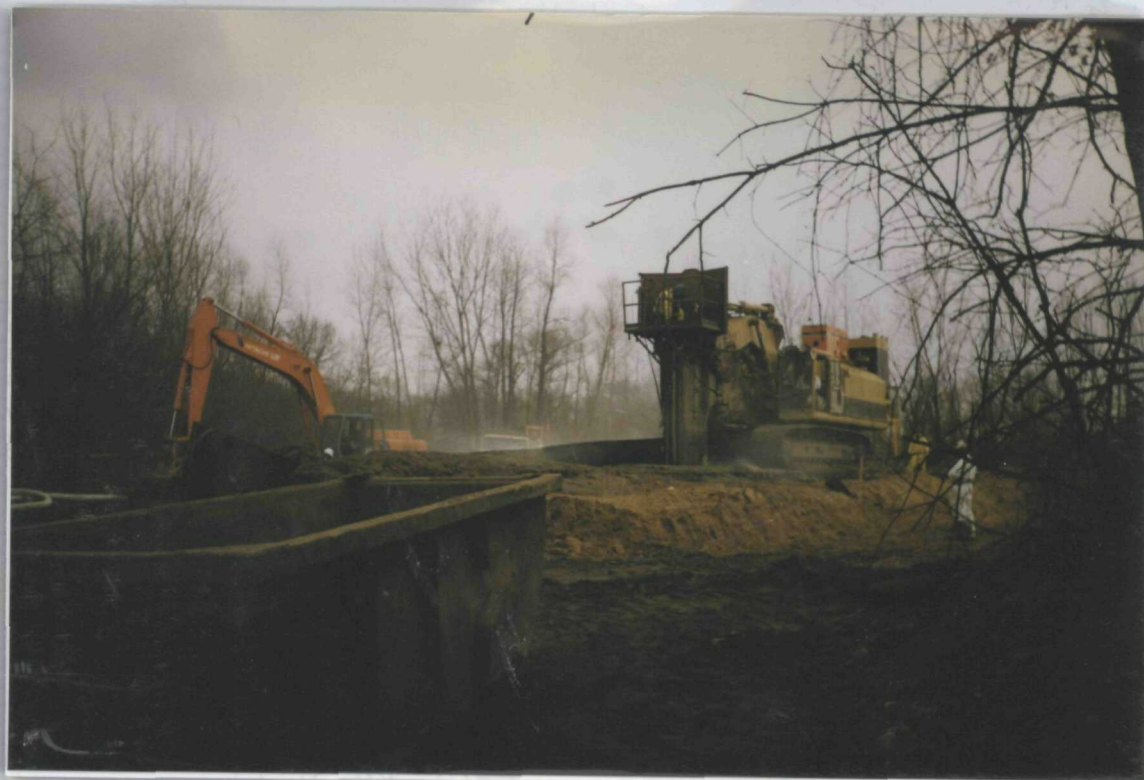
Site: American Chemical Services, Inc. RD/ERA
Proj. #: 71670.600
Roll: 1 Photo #: 35
Date: 02-06-97 Time: 0955
Photographer: Ashok Rupani
Description: Facing west. HTI installing barrier wall in the north-west region of the OFCA.

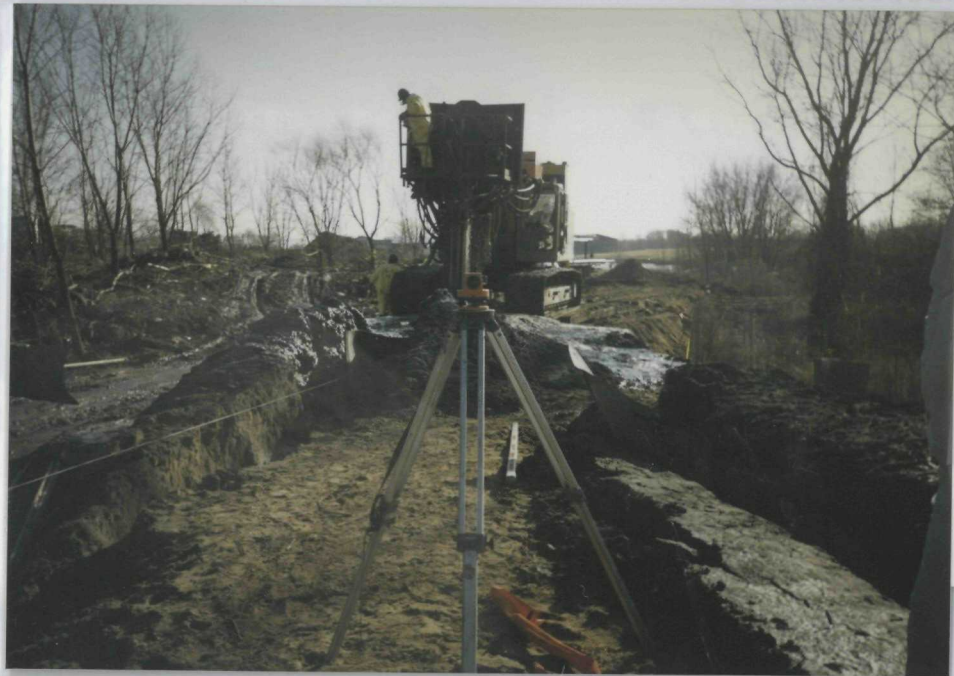
HTI encountered several problems during barrier wall installation activities. On February 14, 1997, the joint between the first and the second HDPE panel pulled apart near station 20+00 as the trenching machine moved forward to unroll the panel. Similar situation arose on March 3, 1997, when the joint between the eighth and the ninth HDPE panel pulled apart near station 12+00. Each time the joint pulled apart, HTI ceased forward progress, made unsuccessful attempts to complete the connection, pulled the installation boot out of the ground to make repairs and modify the delivery system, and finally resumed forward progress leaving a gap between the panels.

Site: American Chemical Services, Inc. RD/ERA
 Proj. #: 71670.600
 Roll: 2 Photo #: 37
 Date: 02-19-97 Time: 1530
 Photographer: Ashok Rupani
 Description: Facing south. After failing to make the first joint, HTI resumes barrier wall installation with a new panel beginning at a location few feet south of the first panel.

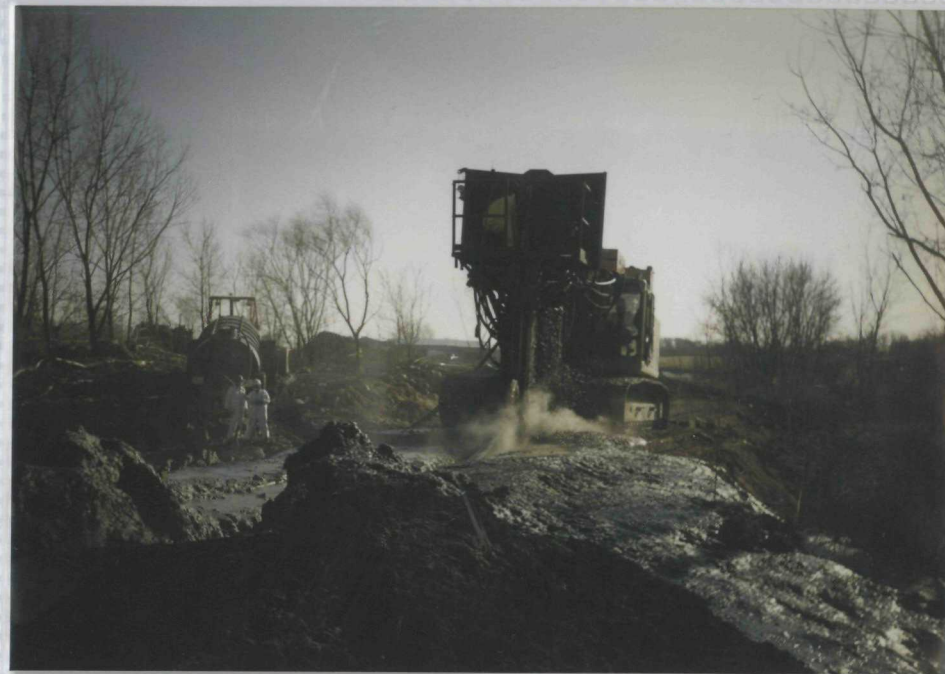
Site: American Chemical Services, Inc. RD/ERA
 Proj. #: 71670.600
 Roll: 2 Photo #: 38
 Date: 02-19-97 Time: 1530
 Photographer: Ashok Rupani
 Description: Facing south-east. After failing to make the first joint, HTI resumes barrier wall installation with a new panel beginning at a location few feet south of the first panel.

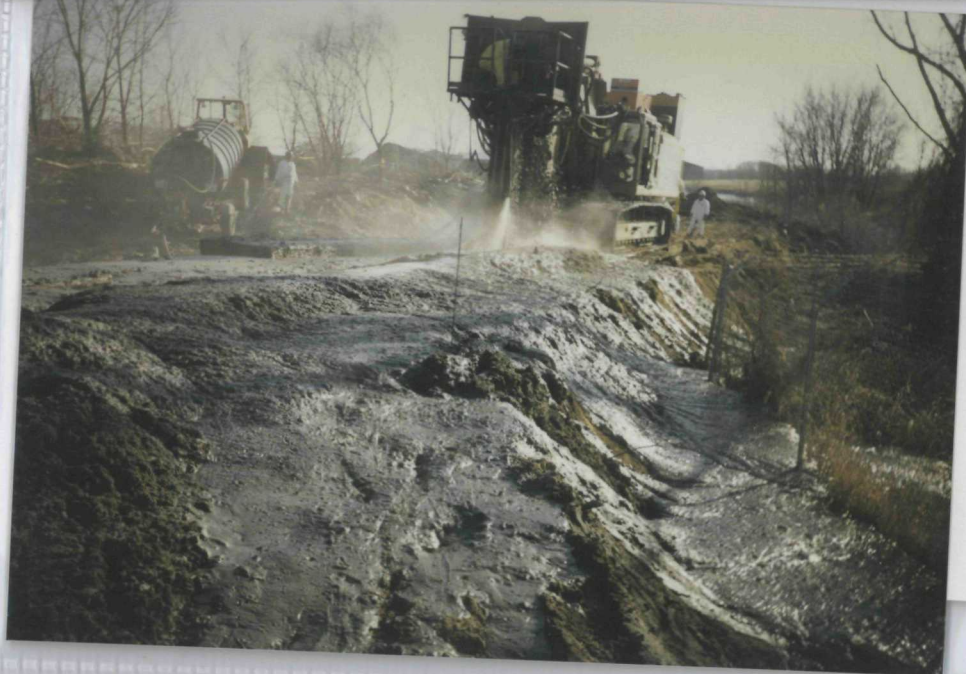
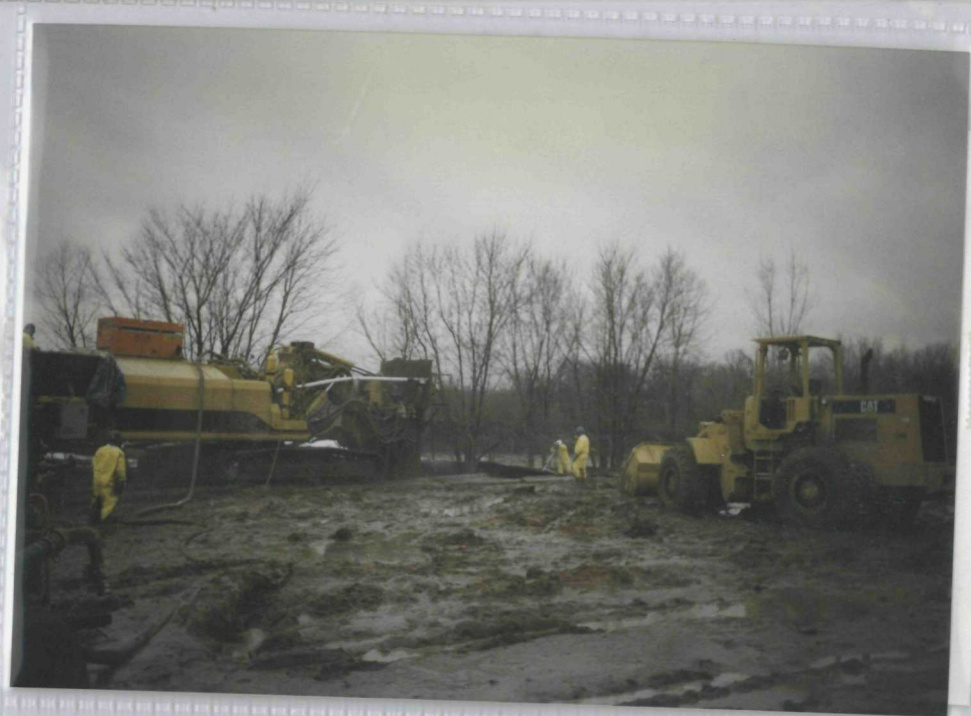
Description: Facing south-east. After failing to make the first joint, HTI resumes barrier wall installation with a new panel beginning at a location few feet south of the first panel.

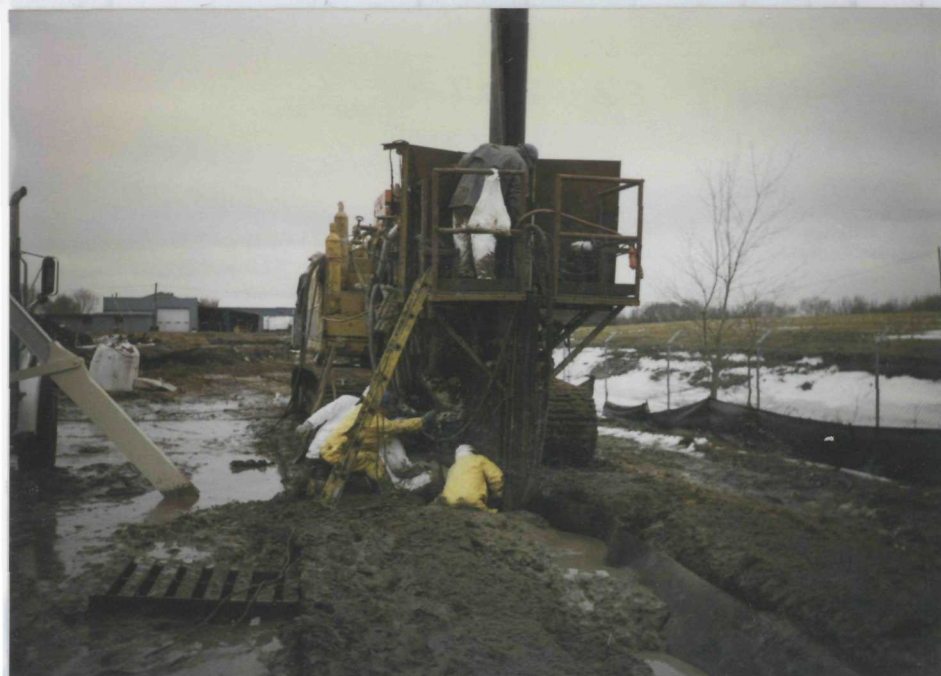
Description: Facing west. HTI making a joint during barrier wall installation along the western leg of the alignment in the OFCA.

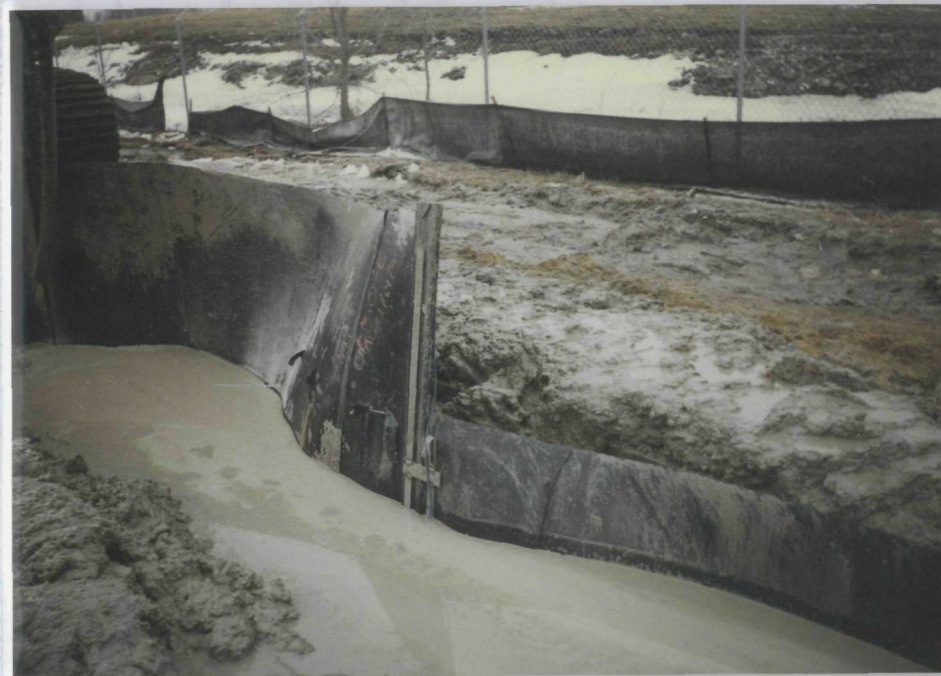
Description: Facing south. HTI trying to resolve problems encountered while making the barrier wall joint.
